GEOLOGICAL AND GEOTECHNICAL CONDITIONS OF HUMAN INTERVENTIONS IN NATURAL VOLCANIC CAVERNS: THE OUTFITTING OF “LOS JAMEOS DEL AGUA” AUDITORIUM, LANZAROTE, CANARY ISLANDS, SPAIN

In this paper this methodology is applied to the well-known auditorium of “Los Jameos del Agua”, located in Lanzarote. This volcanic island forms part of the Canary archipelago. This volcanic tube is visited by more than 800,000 people per year.

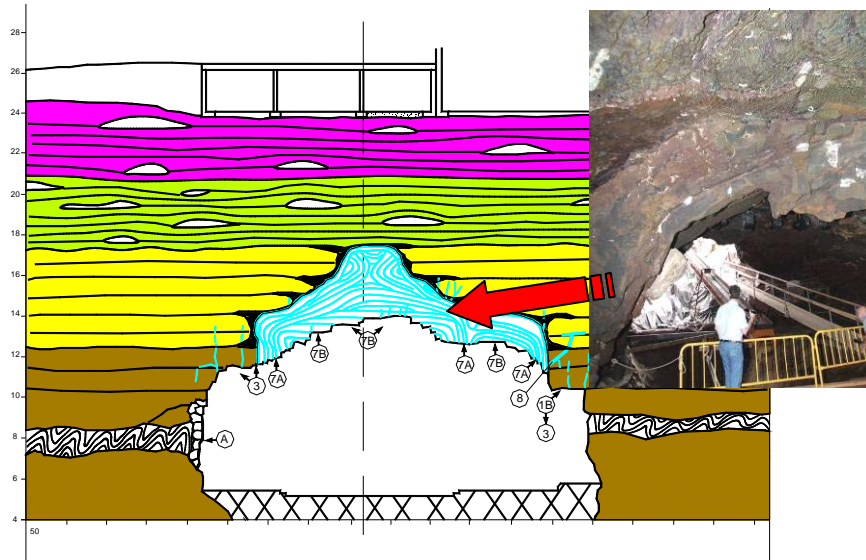
The LTU is spatially limited to the backstage/upstage, the stage and the first 8 rows of seating.

Only in the zone of the backstage does the lava tube structure appear to be in its original state showing thin layers of lava with a concentric shell structure (like an onion) and levees (terraces marking different stages of filling flows). The shell was formed where the lava chilled against the colder rock. Most of the roof appears to be a circular stable arch. The tube profile here is in the shape of an “eight” (two superimposed circles). This profile is the result of the cooling of lava flow surfacing to produce a crust, beginning at the levees and growing inward and downstream.

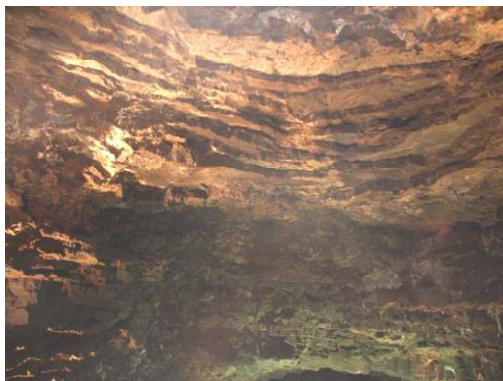
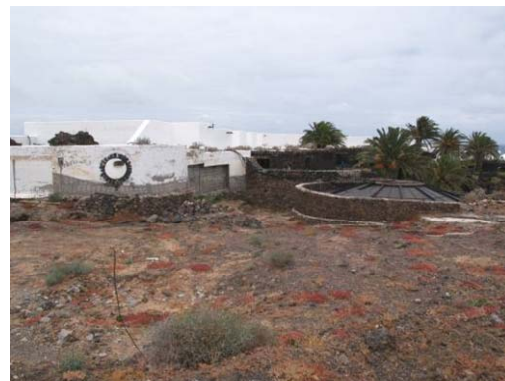
This is the most important type of problem. It is related to the possible collapse of all or part of the arch in the event of exceeding the structure's resistant capacity formed by the actual layers of rock in their natural state. This situation is particularly obvious in the entrance area to the auditorium where there is the additional problem of the rock thickness in the area closest to the entrance Jameo.

This is a laminar-type structure with horizontally structured layers of rock, superimposed which at the same time are not very well bound. Their resistant capacity depends to a large extent not only on the thickness and quality of the rock, depending on the span or the opening of the cavity, but on the degree and type of the existing fractures.

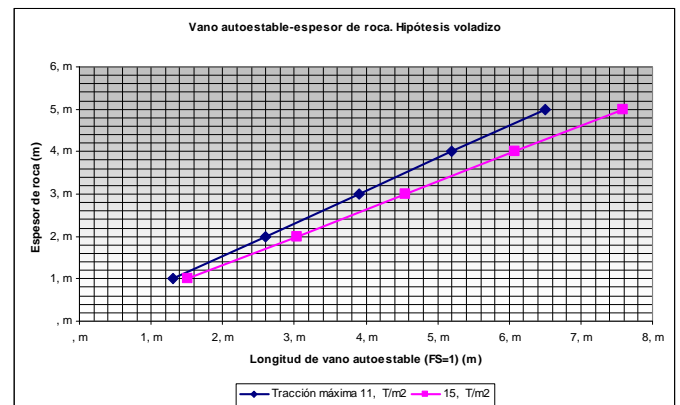
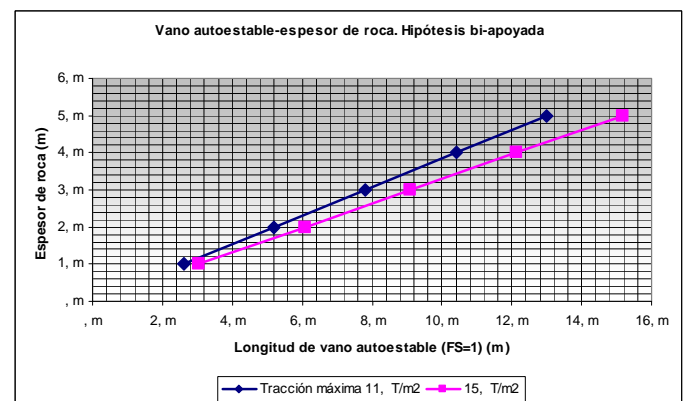
The first attempt to be made was that corresponding to a minimum cantilevering and opening which would be self-supporting and for which a simplification was used treating them as a built-in-free and bi-supported beam (maximum tractions in the centre of the opening) subjected to its own weight. These hypotheses do not take into account the three-dimensional nature of the problem, nor the fact that the numerous subvertical fractures can make blocks become detached. Whilst aware of the degree of conservatism and simplification of the problem that has been assumed the objective was however essentially to have a reference framework of how the group functions.

The cantilevers and openings observed were, in general, close to those calculated. This would imply a strict equilibrium of the structure of the solid mass which would require a reinforcement to allow separating the reinforced situation from the current one with regard to the safety factor. This reinforcement can be focused from the point of view of modifying the working hypotheses of the solid mass using anchoring modifying the thickness of competent rock, thus increasing, if possible, its average resistance to traction (a possible approach would be to incorporate an artificial stratum over the surface) or a combination of both.

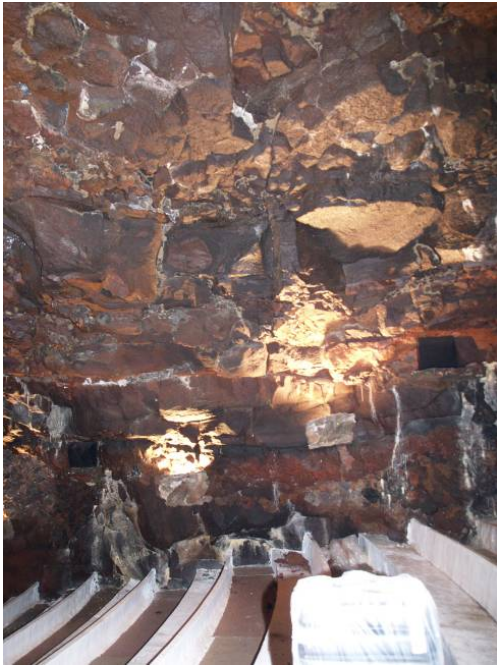
This represents a second level of problems. It was detected throughout practically the entire auditorium and would affect blocks with a size of approximately 50-60 cm.

In some cases the blocks have clearly open joints which could indicate the strict equilibrium of these. Stability would be produced by possible bridges or rock joint contacts with other adjacent blocks.

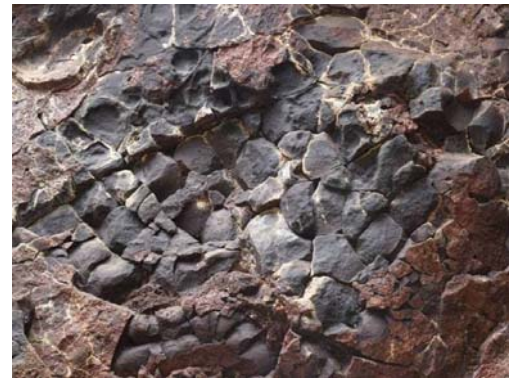
These blocks would be smaller in size, approximately 20 cm, i.e. 1 to 1.6 kN in weight employing an increase of 1.6 as a pessimistic hypothesis. Given the reduced size it would be difficult to apply isolated stabilisation solutions using borings since the area is too small to make a boring without causing the block to become detached.

Based on these premises, the system studied and ultimately used was directed at improving the joint between various blocks thus improving each of these individually. This could give the case of a specific area suffering from a second-level problem once all the smaller blocks have been joined.

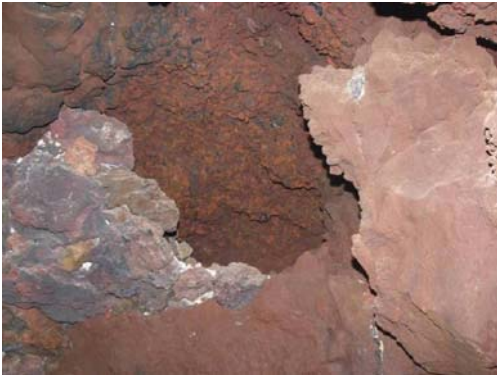
al stress of the cavern. They can occur at any point of its surface as the result of the individualisation of a fragment of rock or due to the loss of cohesion or the reduced resistance of some of the discontinuities or in the actual matrix of which it is comprised as a result of the alteration.

In this sense superficial-type treatments studied focused on consolidating the first centimetres of the material by increasing its cohesion and reducing the susceptibility of the material to erosion.

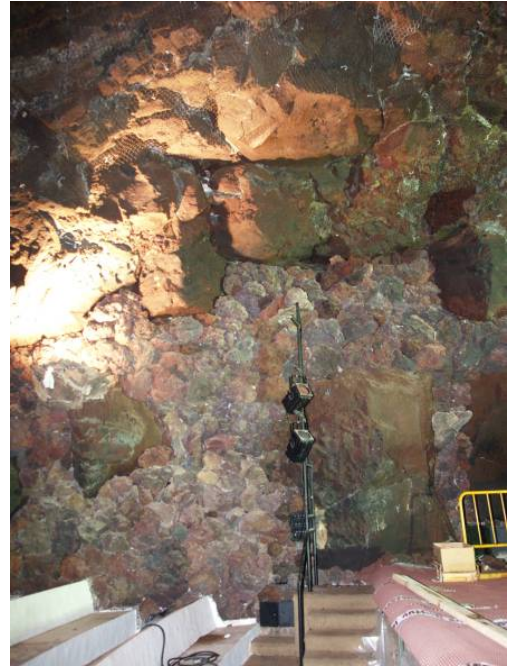
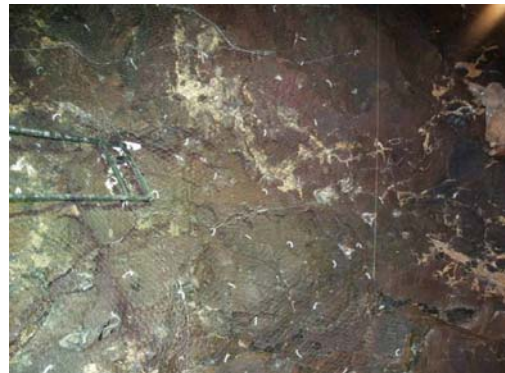
It must be emphasised at times that these strips did not correspond as much with the attempt to fill and conceal gaps, but rather with the attempt to underpin areas with insufficient support and with the objective of concealing existing installations. Examples of this are cases of numerous cables and re-

Within this context it is worth highlighting the existence of a triple torsion protective mesh which was located in the area closest to the stage. This mesh extended from the keystone up to the sidewalls and the fixtures were clearly visible due to their galvanising.

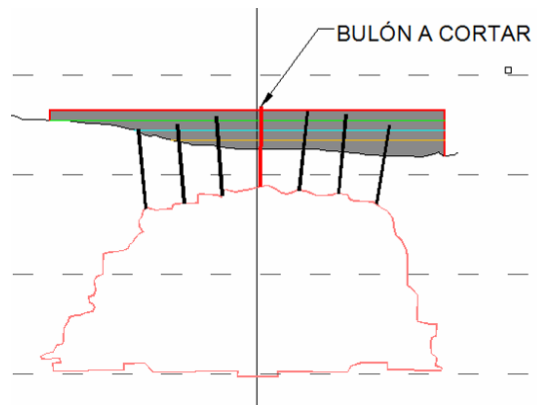
Improved stratum for anchoring the bolts in the entrance area

The aim of this solution is to create an artificial stratum of improved soil in the areas in which the rock thickness in the keystone was considerably reduced. It was considered that this treatment is required up to a profile where the thickness of the rock is practically 8 metres. The reinforcement is intended to prevent, in the long term, the combination of various vertical and horizontal groups of fracturing which could cause a large block to fall. In the event of a block with such characteristics becoming detached, the bolts would ensure that it remained attached.

The objective of this treatment is to create an artificial stratum to anchor the bolts and not, strictly speaking, to create a flagstone-like structural element. Nevertheless, to improve its behaviour with regard to possible tractions or fissures which could arise, a reinforced grating was included with three levels of bars measuring 25 mm in diameter.

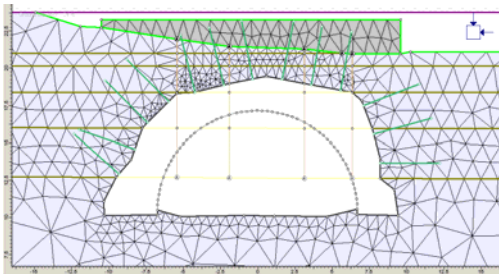
Likewise, to make a more simplified analysis of the effect of this stratum, two finite element models were made which included joining elements to reproduce the generation of one joint throughout the rock solid mass.

In the first calculation model the formation of the auditorium up to its present condition is reproduced in successive phases. In the final phase of the calculation a long-term hypothetical situation is simulated in which the resistant and deformational characteristics of the vertical joints is reduced until achieving the instability of the calculation model. The second model is exactly the same as the first. The only difference is that in the last phase the improved concrete stratum is added and the bolts to verify that this reinforcement manages to stabilise the arch of the auditorium.

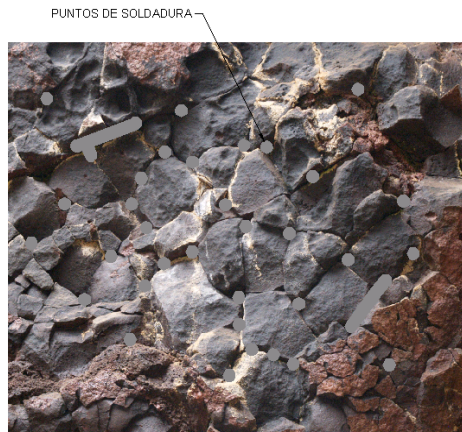
These are the cases where it was not possible to make holes in the blocks due to their small size (third-level problem), i.e. blocks of approx. 20 · 20 cm maximum. This would be equivalent to weights between 1 and 1.6 kN, with an increase factor of 1.6. It was considered joining the blocks by using so-

called “chemical welding”, which is basically the creation of bridges between different blocks using low viscosity epoxy resin weld beads applied manually.

This creates one larger block with which it could, at least theoretically, be possible to treat using micro-seaming. As occurred with treatment 2-A there is already a first previous action level since the generalised injections type 1a have already been performed. This action is therefore complementary in those cases in which there is no safety in the finish of the first action level.
